NACA RM E53H06

EXPERIMENTAL INVESTIGATION OF SEVERAL WATER-INJECTION  
CONFIGURATIONS FOR TURBINE-BLADE SPRAY COOLING  
IN A TURBOJET ENGINE

By John C. Freche and Roy A. McKinnon

Lewis Flight Propulsion Laboratory  
Cleveland, Ohio

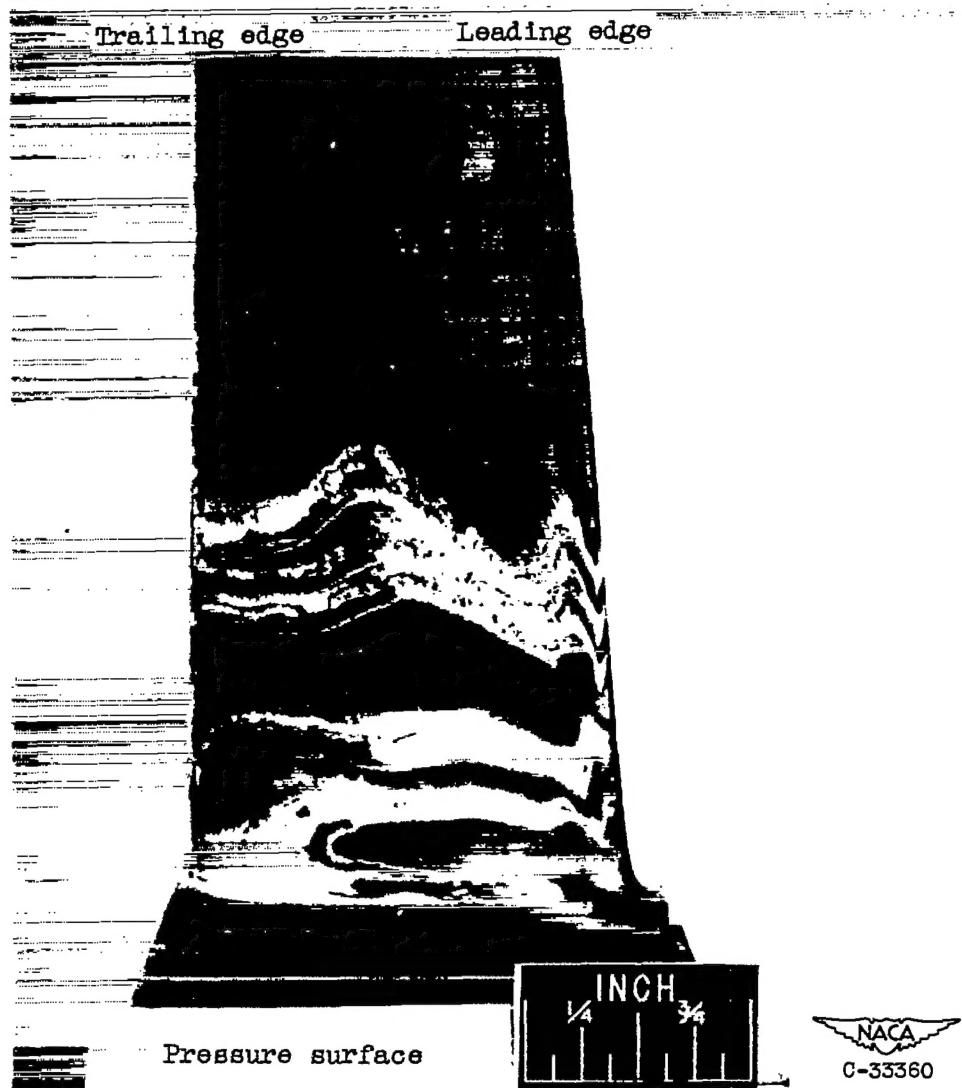
The effect of spray cooling upon blade life is a factor to be considered in view of (1) possible thermal shocks imposed, and (2) thermal stresses introduced in the blades when large chordwise blade temperature differences occur. It is not the purpose of the present investigation

to evaluate either of these problems. In fact, in order to minimize the thermal shock problem, which should be investigated separately prior to any final application of spray cooling, water was injected simultaneously with the engine starts. However, some information can be obtained from the current investigation as to life characteristics of S-816 blades when subjected to large chordwise temperature differences. Three blades developed cracks. One failure occurred on a thermocoupled blade. In a fourth failure, the upper half of the blade was lost, probably as the result of continued propagation of a crack such as that shown in figure 9, which presents a typical blade failure. In all failures, the crack extended forward from the trailing edge at approximately the midspan, which is generally considered a critically stressed blade section for this turbine. The extent of the cracks (penetration from the trailing edge toward the midchord) varies from a minimum of 1/4 to 1 inch. The first blade failure occurred after 15 hours of spray cooling operation. The difference in total blade life between the first and the final failed blade was approximately 2 hours. Three of the four failures occurred during operation with injection configurations which provided the most severe chordwise temperature differences encountered, these configurations being the spray bar and the combined outer- and inner-diameter injection orifices. A limited comparison can be made with the Stellite 21 blades used in the spray cooling investigation described in reference 1. The bulk of the engine operation in the investigation of reference 1 was conducted at lower speeds and at stress levels approximately 1/8 and 1/2 the blade stress encountered at rated speed. Practically all engine operation in the current investigation was conducted at rated engine speed. On this basis, it appears that S-816 blades are more resistant to failure induced by the added stresses introduced through large chordwise temperature differences. It should be noted again that if these temperature differences can be eliminated by use of suitable injection configurations, blade life probably will be increased. In that case, the magnitude of possible thermal shock to the blades must still be evaluated to determine the full effect of spray cooling on blade life.

Figure 9. - Rotor blade after spray cooling operation showing trailing edge crack typical of blade failures encountered when large chordwise temperature differences were measured at midspan.

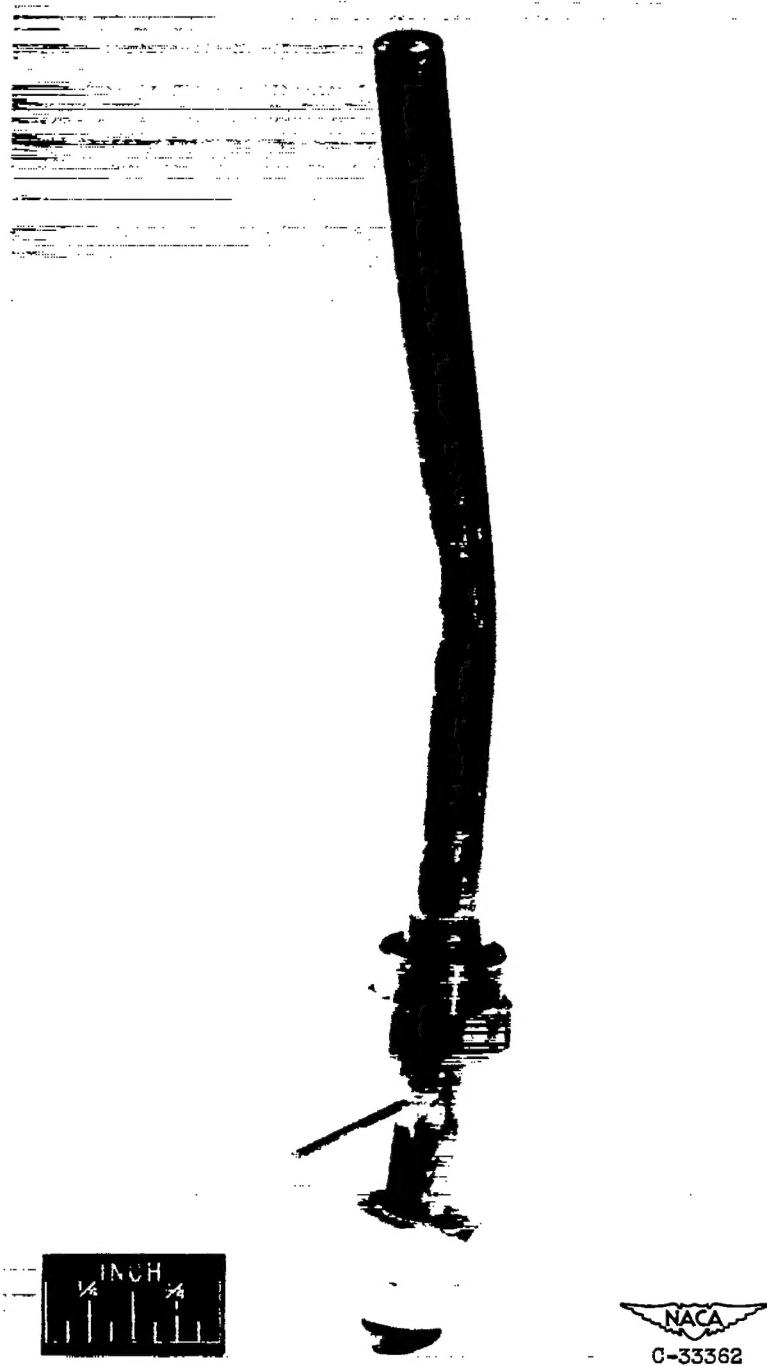
and the spray bar used in the present investigation. Figure 12 indicates the condition of an Inconel spray bar after approximately 1 hour of rated speed operation both with and without spray cooling. It is apparent that the combination of gas forces and gas temperature has bent the bar after a relatively short period of operation and that prolonged operation would probably have resulted in failure of the spray bar. Although it may be possible to provide sufficient reinforcement to prevent such bending or even to provide a means of retracting the bar from the gas stream when not in use, additional undesirable complexities would be introduced. Thus, besides its relatively low cooling effectiveness, the spray bar has other major disadvantages.

Figure 12. - Inconel spray bar after approximately 1 hour of engine operation at rated speed with and without spray cooling.
